**Flood Control Project Maintenance  
Levee Inspections**  
**LMA District Cover Sheet**  
**Spring 2019 Levee Inspection Results**

**Sutter Maintenance Yard East-West Interceptor**

**Spring 2019 Levee Inspection Results**

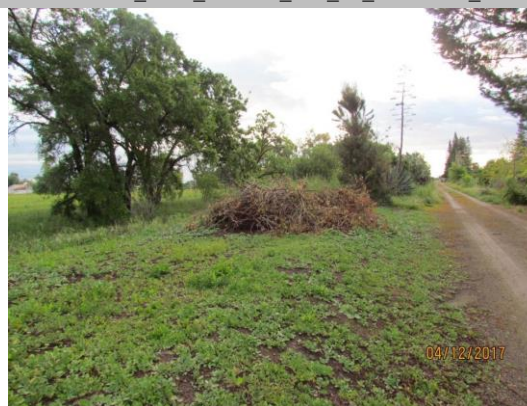
Photo 1 of 1 : SP\_2019\_ST0020\_213\_12\_20190327\_00007.jpg

LM Start	0.20	Rating **	M	Issue No.	12
LM End	0.20	Issue Type +	En	Location *	WS
Category	Earthen Levee			GPS Latitude/Longitude	
				Start	End
Item	Encroachments			39.171565 °	39.171565 °
				-121.756293 °	-121.756293 °
DWR ID	DWR_ST0020_01_s_2017_12				
Comment Code					
PR : Prunings					
Inspector Comment					
Remove the prunings from the waterside slope.

View of the prunings along the waterside slope.

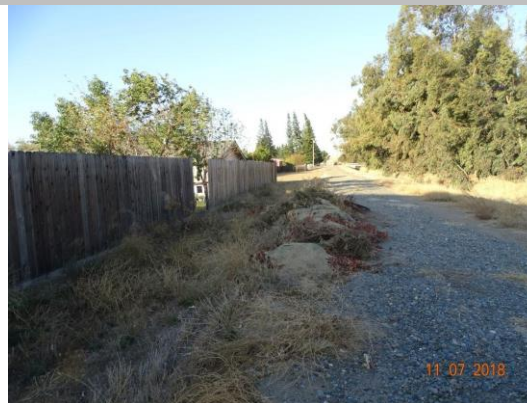
Photo 1 of 1 : SP\_2019\_ST0020\_213\_14\_20190327\_00008.jpg

LM Start	0.45	Rating **	M	Issue No.	14
LM End	0.45	Issue Type +	En	Location *	LS
Category	Earthen Levee			GPS Latitude/Longitude	
				Start	End
Item	Encroachments			39.171453 °	39.171453 °
				-121.751603 °	-121.751603 °
DWR ID	DWR_ST0020_01_f_2018_14				
Comment Code					
PR : Prunings					
Inspector Comment					
Removed the prunings from the landside crown.

View of the prunings along the landside crown.

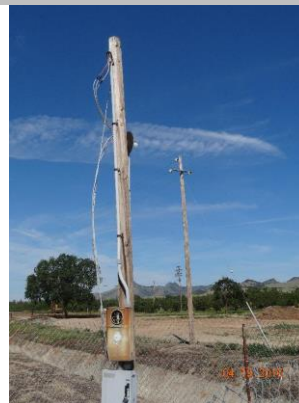
Photo 2 of 3 : UCIP\_SP\_2019\_53691\_74963.jpg

Meter removed from box and disconnected power lines

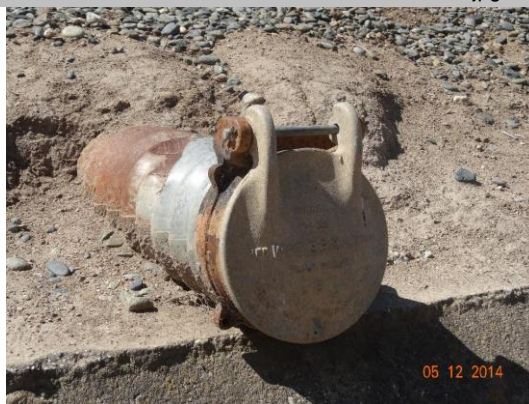
Photo 2 of 3 : UCIP\_SP\_2019\_53693\_64400.jpg

Comment Code					
Inspector Comment					
FS_ID:53693 DS_ID:20115 EP_NO: N/A Repair Type: Non-Urgent Crossing Status: Found UCIP Comments: 02/12/2019 (O. Magana - DWR UCIP)4/10/2017 Overgrown vegetation was blocking access to this pipe. It was not inspected. (DWR Sutter Yard- AFreitag)10/11/2016 Crossing appears to be in good condition.(DWR Sutter Yard - afreitag)4/19/2016 Crossing appears to be in good condition.5/12/2015 Crossing appears in good condition. No noticeable issues to report.11/17/2014 Same as last inspection.5/12/2014 New flapgate installed on WS pipe end.11/4/2013 Same as last inspection.5/15/2013 Same as last inspection.10/16/2012 Pipe not permitted and has no flap gate. FIELD_STRUCT_DESC: 8-inch corrugated metal drainage pipe through the levee, 1.5 feet below the crown. Outlet visible on the waterside (WS). Unable to locate the inlet on the landside (LS). No permit has been identified since crossing was field discovered in 2012. Pipe drains adjacent property. FS Date: 2/12/2019 10:19:00 AM

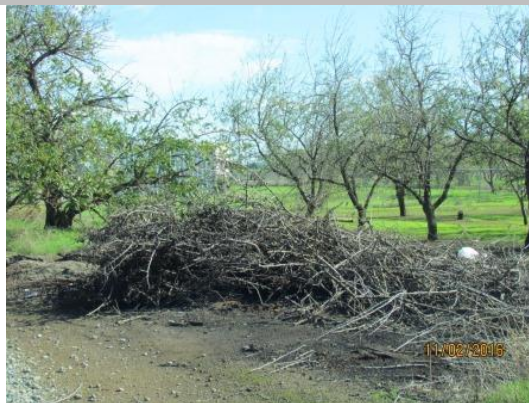
Photo 1 of 1 : SP\_2019\_ST0020\_213\_21\_20190327\_00013.jpg

LM Start	1.26	Rating **	M	Issue No.	21
LM End	1.26	Issue Type +	En	Location *	LS
Category	Earthen Levee			GPS Latitude/Longitude	
				Start	End
Item	Encroachments			39.171227 °	39.171227 °
				-121.736548 °	-121.736548 °
DWR ID	DWR_ST0020_01_f_2016_21				
Comment Code					
PR : Prunings					
Inspector Comment					
Remove prunings from the landside toe.

View of the prunings along the landside toe.

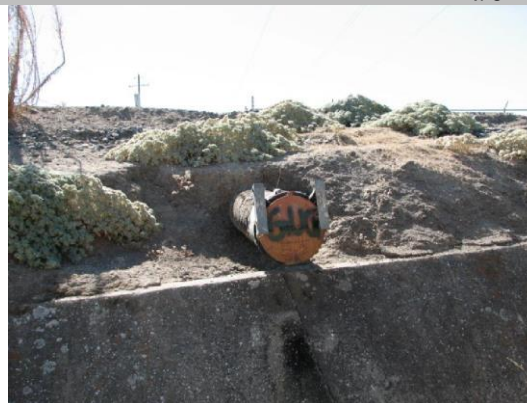
Photo 2 of 3 : UCIP\_SP\_2019\_53831\_11349.jpg

Comment Code						
Inspector Comment						
FS_ID:53831 DS_ID:19432 EP_NO: 15946 Repair Type: Urgent Crossing Status: Found UCIP Comments: 02/12/2019 (O. Magana - DWR UCIP)4/10/2017 Crossing appears to be in good condition. (DWR Sutter Yard-AFreitag)10/11/2016 Crossing appears to be in good condition. (DWR Sutter Yard - afreitag)4/19/2016 LS inlet has been cleaned out. Crossing appears in good condition.5/12/2015 LS inlet is still completely blocked with soil.11/17/2014 Same as last inspection.5/12/2014 Same as last inspection.5/15/2013 Same as last inspection.11/4/2013 Same as last inspection.10/16/2012 Inlet is completely blocked with soil. FIELD_STRUCT_DESC: 12-inch corrugated metal drainage pipe through the levee, 2 feet below the crown. Pipe is encased in concrete. Flap gate is located on the waterside (WS). Landside (LS) inlet filled with soil. (12-inch and 6-inch pipes, different locations, authorized under Permit No. 15946, 1992 - Sutter Community Services District; design sketch available in permit, page 21-23). FS Date: 2/12/2019 10:19:00 AM

Flap gate and pipe at canal.

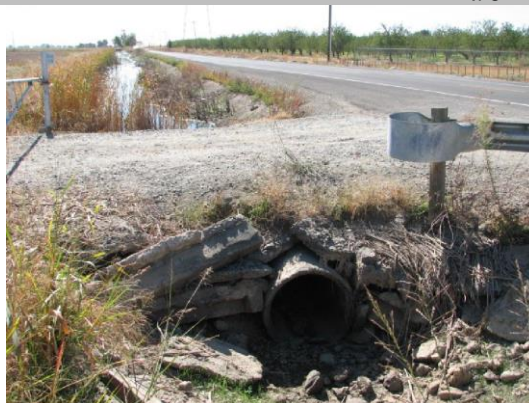
Photo 1 of 3 : UCIP\_SP\_2019\_53696\_11353.jpg

Comment Code						
Inspector Comment						
FS_ID:53696 DS_ID:19422 EP_NO: N/A Repair Type: Non-Urgent Crossing Status: Found UCIP Comments: 02/12/2019 (O. Magana - DWR UCIP)4/10/2017 Crossing appears to be in good condition. Pipe material is concrete. (DWR Sutter Yard- AFreitag)10/11/2016 Crossing appears to be in good condition. (DWR Sutter Yard - afreitag)4/19/2016 Crossing appears to be in good condition.5/12/2015 Crossing appears in good condition. No noticeable issues to report.11/17/2014 Same as last inspection.5/12/2014 Same as last inspection.11/4/2013 Same as last inspection.5/15/2013 Same as last inspection. FIELD_STRUCT_DESC: 30-inch reinforced concrete irrigation pipe through the levee, 2 feet below the crown. 30-inch steel pipe also passes over canal in same alignment. [Additional Reference(s): DWR Levee Log, Revised 1990]. FS Date: 2/12/2019 10:20:00 AM

WS of pipe at outlet.

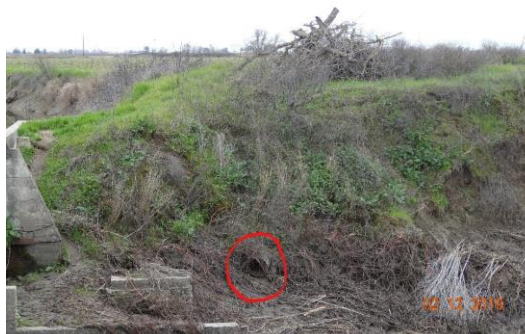
Photo 2 of 3 : UCIP\_SP\_2019\_53743\_78939.jpg

Comment Code						
Inspector Comment						
FS_ID:53743 DS_ID:19424 EP_NO: N/A Repair Type: Non-Urgent Crossing Status: Found UCIP Comments: 02/12/2019 Pump and power pole have been removed. 15-inch pipe through the levee was found. Limited access to levee crown, UCIP inspection was completed by accessing the opposite bank. (O. Magana - DWR UCIP)4/10/2017 Unable to locate. (DWR Sutter Yard- A Freitag)10/11/2016 Unable to locate.4/19/2016 Unable to locate.5/12/2015 Unable to locate.11/17/2014 Unable to locate.5/12/2014 Same as last inspection.11/4/2013 Same as last inspection.5/15/2013 Same as last inspection. Unable to locate.10/16/2012 Unable to locate. FIELD_STRUCT_DESC: 15-inch galvanized iron irrigation pipe through the levee, at an unknown depth. 15 horsepower (HP) pump and power pole located on the waterside (WS). [Additional Reference(s): DWR Levee Log, 1990. USACE Sacramento O&M Manual 135, May 1953, (HLM 0.27), Page 11, Location Section 10, As-Built Drawing No. 50-10-2816]. FS Date: 2/12/2019 12:15:00 PM

WS view: evidence that 15-inch pipe is still present through levee.

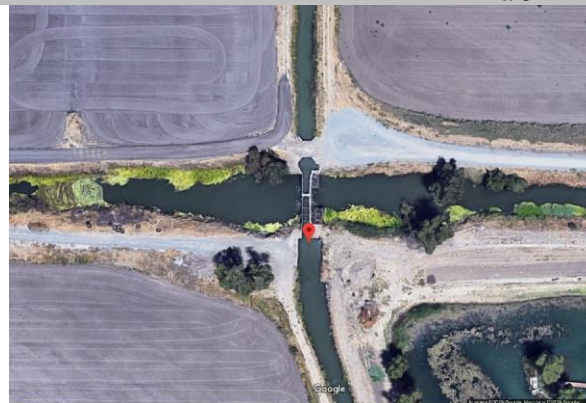
Photo 1 of 3 : UCIP\_SP\_2019\_53744\_78946.jpg

Overview of structure through non-levee section.

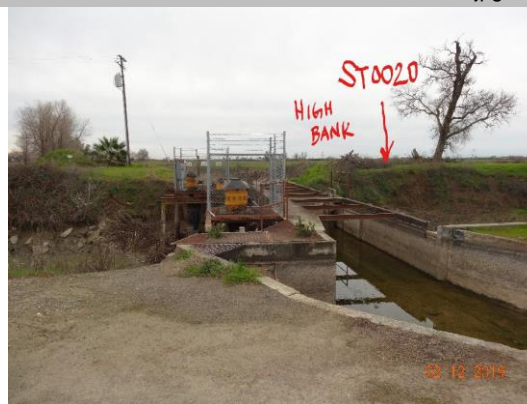
Photo 2 of 3 : UCIP\_SP\_2019\_53744\_78940.jpg

Overview of levee section (high ground) where pumping structure is located, photo taken from opposite bank.

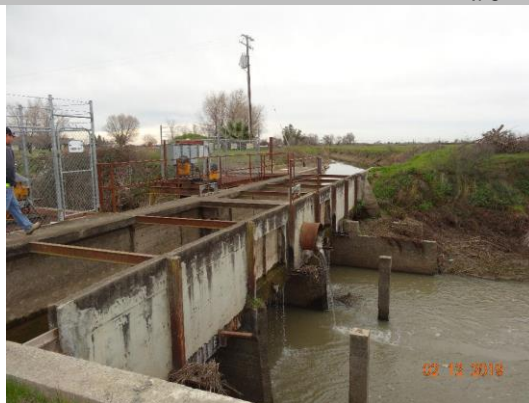
Photo 3 of 3 : UCIP\_SP\_2019\_53744\_78941.jpg

Comment Code						
Inspector Comment						
FS_ID:53744 DS_ID:20116 EP_NO: N/A Repair Type: Non-Urgent Crossing Status: Found UCIP Comments: 02/12/2019 (O. Magana - DWR UCIP)4/10/2017 Crossing appears to be in good condition. (DWR Sutter Yard-AFreitag)10/11/2016 Crossing appears to be in good condition. (DWR Sutter Yard - afreitag)4/19/2016 Crossing appears to be in good condition.5/12/2015 Crossing appears in good condition. No noticeable issues to report.11/17/2014 Same as last inspection.5/12/2014 Same as last inspection.11/4/2013 Same as last inspection.5/15/2013 Same as last inspection. FIELD_STRUCT_DESC: *NOT THROUGH LEVEE* 22-inch steel irrigation pipe through the levee, 2.5 feet below the crown. Pumping plant located on the waterside (WS) shoulder. Pipe, flap gate, vent, and headwall located on the landside (LS) in canal. Metal pier in stream with flap gate on the LS. 8-inch standpipe/vent on the LS. No permit has been identified since crossing was field discovered in 2012. FS Date: 2/12/2019 12:16:00 PM

WS view: irrigation structure (west side), photo taken from opposite bank.

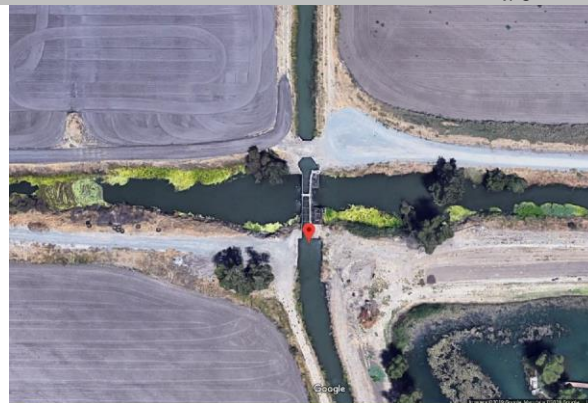
Photo 1 of 3 : UCIP\_SP\_2019\_53745\_78953.jpg

Overview of structure through non-levee section.

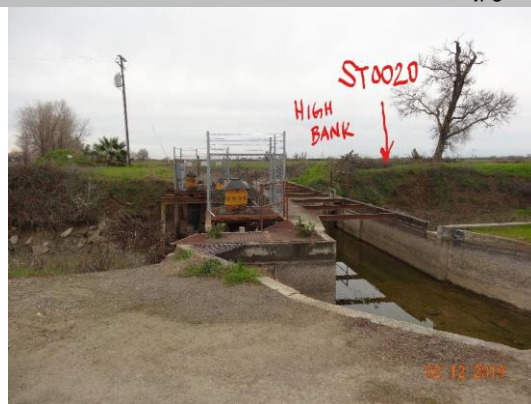
Photo 2 of 3 : UCIP\_SP\_2019\_53745\_78947.jpg

Overview of levee section (high ground) where pumping structure is located, photo taken from opposite bank.

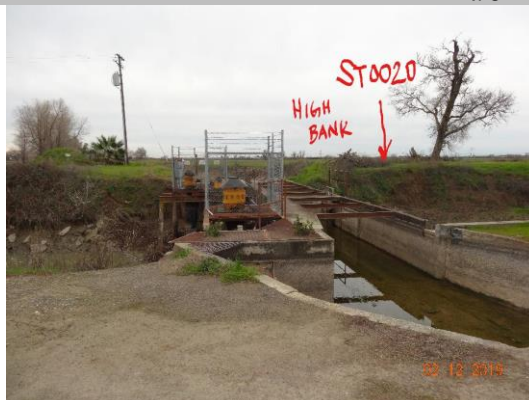
Photo 1 of 3 : UCIP\_SP\_2019\_53746\_78954.jpg

Overview of levee section (high ground) where pumping structure is located, photo taken from opposite bank.

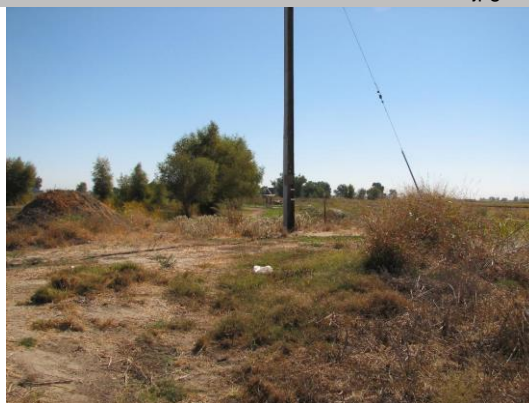
Photo 2 of 3 : UCIP\_SP\_2019\_53746\_14332.jpg

power pole likely end point for pipe.

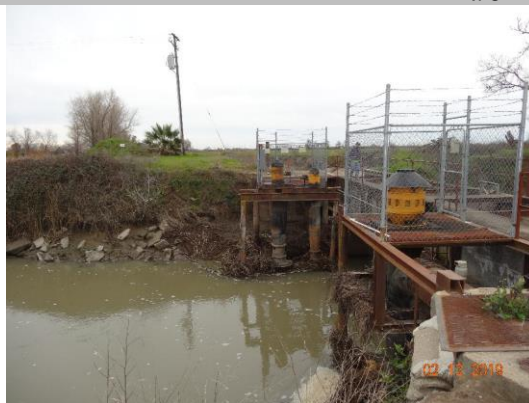
Photo 3 of 3 : UCIP\_SP\_2019\_53746\_78956.jpg

Comment Code						
Inspector Comment						
FS_ID:53746 DS_ID:20118 EP_NO: N/A Repair Type: Non-Urgent Crossing Status: Found UCIP Comments: 02/12/2019 (O. Magana - DWR UCIP)4/10/2017 Crossing appears to be in good condition. (DWR Sutter Yard-AFreitag)10/11/2016 Crossing appears to be in good condition.(DWR Sutter Yard - afreitag)4/19/2016 Crossing appears to be in good condition.5/12/2015 Crossing appears in good condition. No noticeable issues to report.11/17/2014 Same as last inspection.5/12/2014 Same as last inspection.11/4/2013 Same as last inspection.5/15/2013 Same as last inspection. FIELD_STRUCT_DESC: *NOT THROUGH LEVEE* 3-inch galvanized iron electrical conduit through the levee, 4 feet below the crown. No permit has been identified since crossing was field discovered in 2012. FS Date: 2/12/2019 12:16:00 PM

WS view: irrigation structure (east side), photo taken from opposite bank.

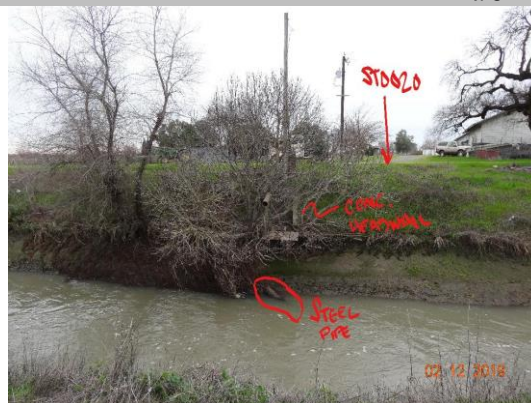
Photo 1 of 3 : UCIP\_SP\_2019\_53704\_78958.jpg

Comment Code						
Inspector Comment						
FS_ID:53704 DS_ID:19425 EP_NO: N/A Repair Type: Non-Urgent Crossing Status: Found UCIP Comments: 02/12/2019 (O. Magana - DWR UCIP)4/10/2017 Abandoned. (DWR Sutter Yard- AFreitag)10/11/2016 Abandoned crossing.(DWR Sutter Yard - afreitag)4/19/2016 Abandoned crossing.5/12/2015 Abandoned crossing.11/17/2014 Same as last inspection.5/12/2014 Same as last inspection.11/4/2013 Same as last inspection.5/15/2013 Same as last inspection.10/16/2012 Pipe and pump abandoned. Pipe should be removed or properly abandoned. FIELD_STRUCT_DESC: 8-inch galvanized iron irrigation pipe through the levee, 2 feet below the crown. 7.5 horsepower (HP) pump located in canal on the waterside (WS). [Additional Reference(s): DWR Levee Log, 1990. USACE Sacramento O&M Manual 135 (revision), May 1953, (HLM 0.39), Page 11, Location Section 12, As-Built Drawing No. 50-10-2816]. FS Date: 2/12/2019 12:17:00 PM

Overview of levee section (high ground), photo taken from opposite bank.

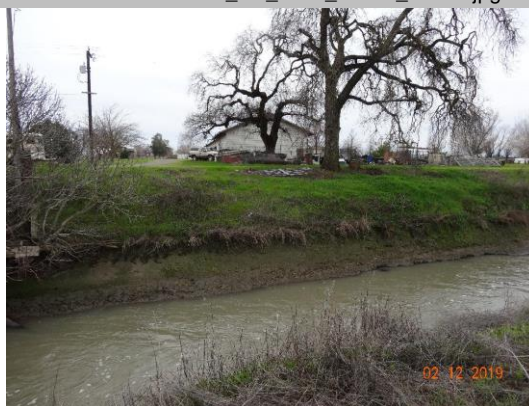
Photo 2 of 3 : UCIP\_SP\_2019\_53704\_78959.jpg

Overview of levee section (high ground), photo taken from opposite bank just upstream from pipe crossing.

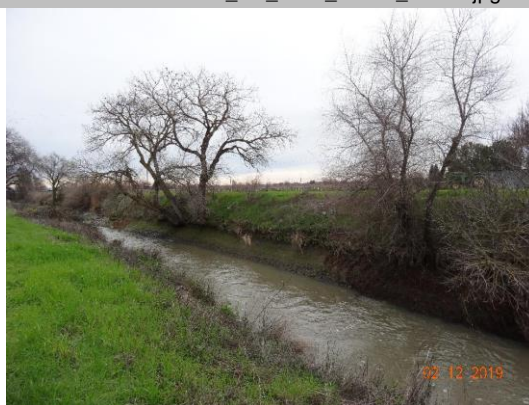
Photo 3 of 3 : UCIP\_SP\_2019\_53704\_78960.jpg

Overview of levee section (high ground), photo taken from opposite bank just downstream from pipe crossing.

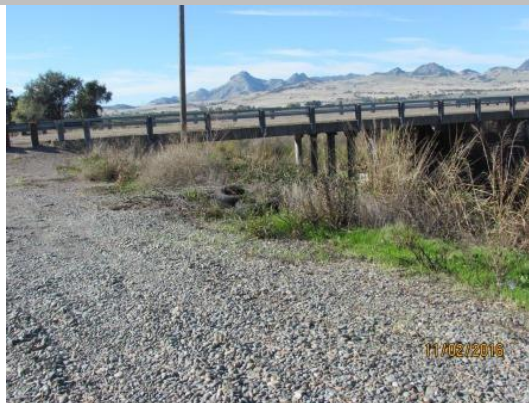
Photo 1 of 1 : SP\_2019\_ST0020\_214\_28\_20190327\_00012.jpg

LM Start	0.53	Rating **	M	Issue No.	28
LM End	0.53	Issue Type +	En	Location *	WS
Category	Earthen Levee			GPS Latitude/Longitude	
				Start	End
Item	Encroachments			39.171028 °	39.171028 °
				-121.716475 °	-121.716475 °
DWR ID	DWR_ST0020_02_s_2016_28				
Comment Code					
DE : Debris					
Inspector Comment					
Tires and tree clippings on WS crown.

View of the tires along the waterside berm.

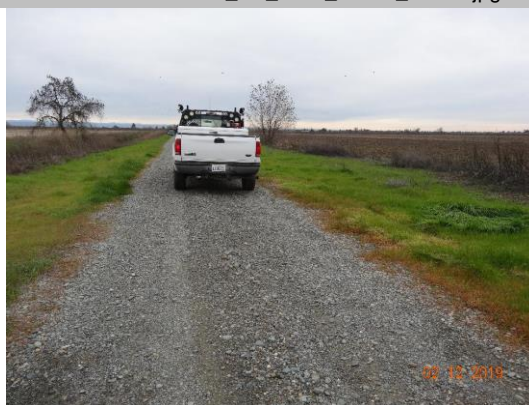
Photo 1 of 3 : UCIP\_SP\_2019\_53705\_78964.jpg

Comment Code					
Inspector Comment					
FS_ID:53705 DS_ID:19426 EP_NO: N/A Repair Type: Non-Urgent Crossing Status: Found UCIP Comments: 02/12/2019 (O. Magana - DWR UCIP)4/10/2017 Abandoned. (DWR Sutter Yard- A Freitag)10/11/2016 Abandoned crossing.(DWR Sutter Yard - a Freitag)4/19/2016 Abandoned crossing.5/12/2015 Abandoned crossing. Needs to be properly abandoned.11/17/2014 Same as last inspection.5/12/2014 Same as last inspection.11/4/2013 Same as last inspection.5/15/2013 Same as last inspection.10/16/2012 Pumping plant abandoned. Pipe abandoned and only visible at bottom of concrete standpipe. Pipe needs to be abandoned properly. FIELD_STRUCT_DESC: 12-inch galvanized iron irrigation pipe through the levee, 6 feet below the crown. 10 horsepower (HP) pump in the canal, and power pole located on the waterside (WS). 36-inch concrete standpipe located on the landside (LS) shoulder. [Additional Reference(s): DWR Levee Log, 1990. USACE Sacramento O&M Manual 135, May 1953, (HLM 0.74), Page 11, Location Section 19, As-Built Drawing No. 50-10-2816]. FS Date: 2/12/2019 12:18:00 PM

Overview of levee section (high ground) where pipe crosses.

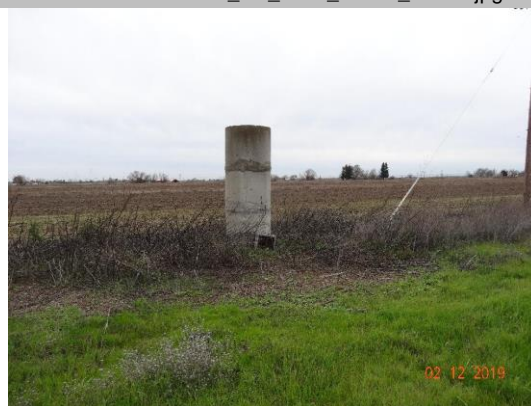
Photo 2 of 3 : UCIP\_SP\_2019\_53705\_78963.jpg

LS view: concrete standpipe located on the LS.

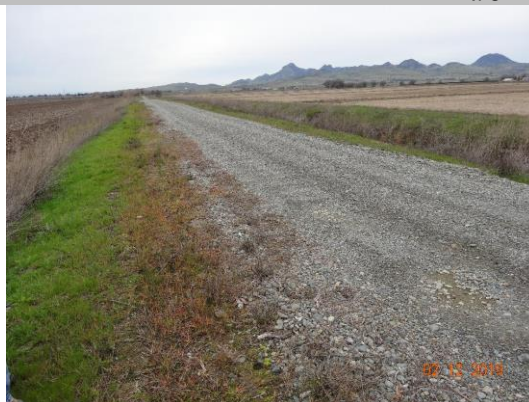
Photo 2 of 3 : UCIP\_SP\_2019\_53706\_78967.jpg

Overview of levee section (high ground) where pipe should cross.

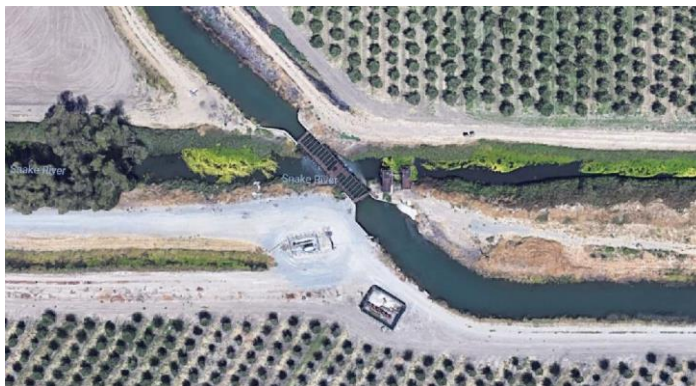
Photo 1 of 3 : UCIP\_SP\_2019\_53747\_78979.jpg

Comment Code					
Inspector Comment					
FS_ID:53747 DS_ID:19429 EP_NO: N/A Repair Type: Non-Urgent Crossing Status: Found UCIP Comments: 02/12/2019 (O. Magana - DWR UCIP)4/10/2017 Crossing appears to be in good condition. (DWR Sutter Yard-AFreitag)10/11/2016 Crossing appears to be in good condition. (DWR Sutter Yard - afreitag)4/19/2016 Crossing appears to be in good condition.5/12/2015 Crossing appears in good condition. No noticeable issues to report.11/17/2014 Same as last inspection.5/12/2014 Same as last inspection.11/4/2013 Same as last inspection.5/15/2013 Same as last inspection. FIELD_STRUCT_DESC: *NOT THROUGH LEVEE* 1 of 2: 36-inch steel irrigation pipe through the levee, 2 feet below the crown. Pump house on platform in canal. Flap gates in Sutter Slough. 7-inch diameter air vent riser located on the landside (LS) shoulder. Power pole on levee with electrical box. [Additional Reference(s): DWR Levee Logs, Revised 1990] FS Date: 2/12/2019 12:19:00 PM

Overview of structure through the non-levee section.

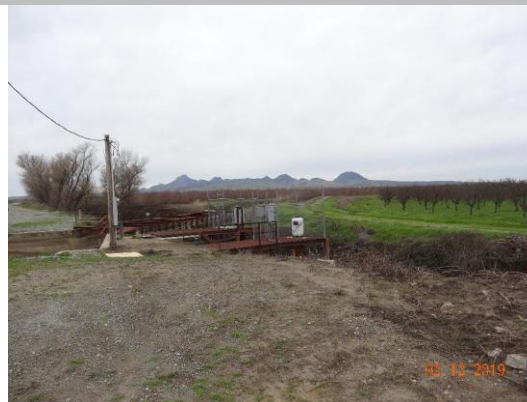
Photo 2 of 3 : UCIP\_SP\_2019\_53747\_78973.jpg

Overview of structure located on the the East-West Interceptor, photo 1 of 2.

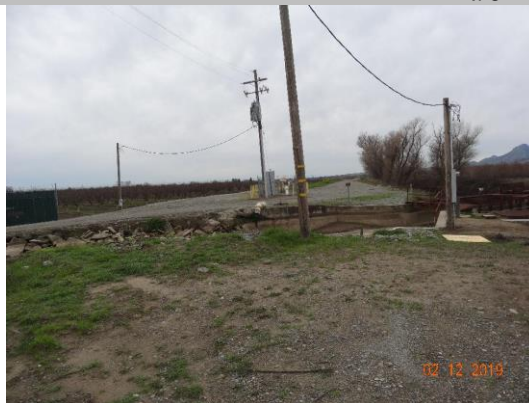
Photo 3 of 3 : UCIP\_SP\_2019\_53747\_78974.jpg

Comment Code						
Inspector Comment						
FS_ID:53747 DS_ID:19429 EP_NO: N/A Repair Type: Non-Urgent Crossing Status: Found UCIP Comments: 02/12/2019 (O. Magana - DWR UCIP)4/10/2017 Crossing appears to be in good condition. (DWR Sutter Yard-AFreitag)10/11/2016 Crossing appears to be in good condition. (DWR Sutter Yard - afreitag)4/19/2016 Crossing appears to be in good condition.5/12/2015 Crossing appears in good condition. No noticeable issues to report.11/17/2014 Same as last inspection.5/12/2014 Same as last inspection.11/4/2013 Same as last inspection.5/15/2013 Same as last inspection. FIELD_STRUCT_DESC: *NOT THROUGH LEVEE* 1 of 2: 36-inch steel irrigation pipe through the levee, 2 feet below the crown. Pump house on platform in canal. Flap gates in Sutter Slough. 7-inch diameter air vent riser located on the landside (LS) shoulder. Power pole on levee with electrical box. [Additional Reference(s): DWR Levee Logs, Revised 1990] FS Date: 2/12/2019 12:19:00 PM

Overview of structure located on the the East-West Interceptor, photo 2 of 2.

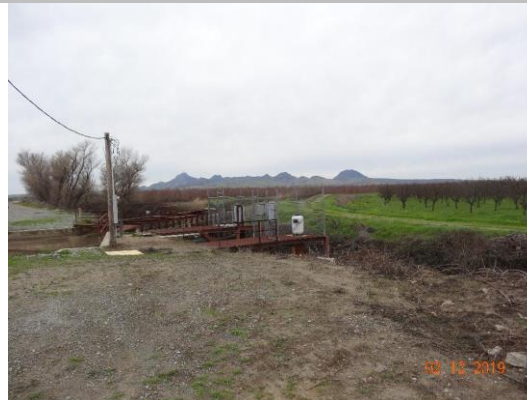
Photo 2 of 3 : UCIP\_SP\_2019\_53748\_78981.jpg

Overview of structure located on the East-West Interceptor, photo 1 of 2.

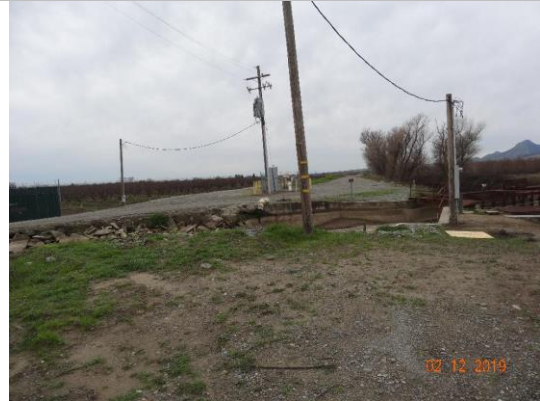
Photo 3 of 3 : UCIP\_SP\_2019\_53748\_78982.jpg

Overview of structure located on the East-West Interceptor, photo 2 of 2.

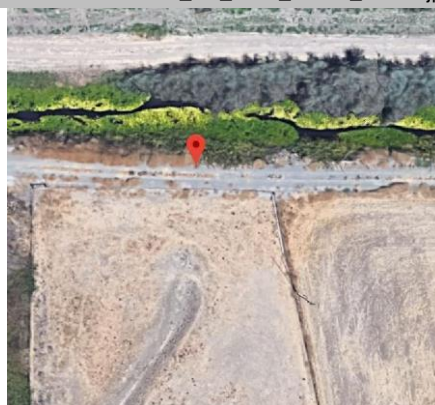
Photo 1 of 3 : UCIP\_SP\_2019\_53710\_78992.jpg

Overview of landside drainage path across levee section.

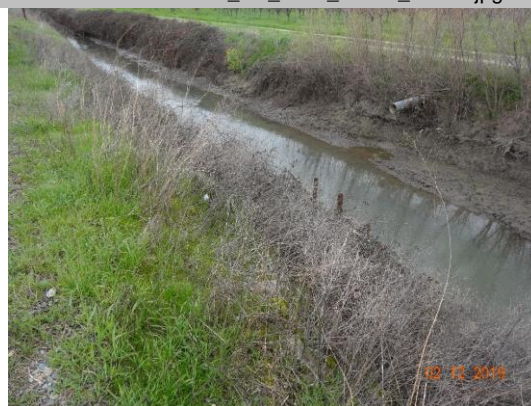
Photo 2 of 3 : UCIP\_SP\_2019\_53710\_78989.jpg

WS view: steep slope with dry vegetation along bank.

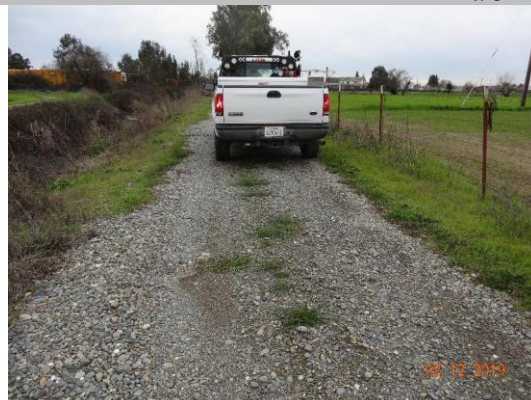
Photo 1 of 3 : UCIP\_SP\_2019\_53711\_78994.jpg

Overview of levee section (high ground) where pipe crosses.

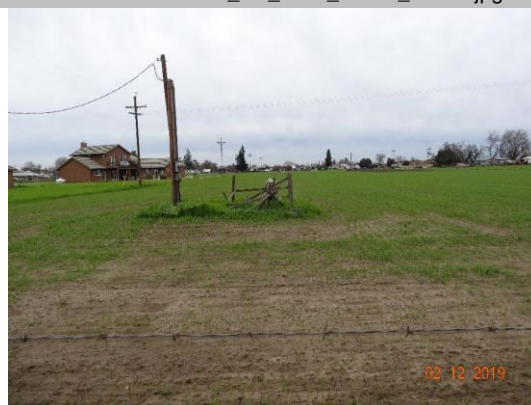
Photo 2 of 3 : UCIP\_SP\_2019\_53711\_78993.jpg

LS view: junction box located on the LS.

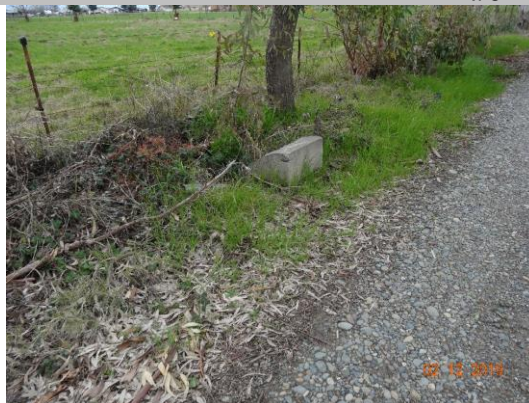
Photo 3 of 3 : UCIP\_SP\_2019\_53712\_78999.jpg

LS view: concrete headwall located on LS shoulder.

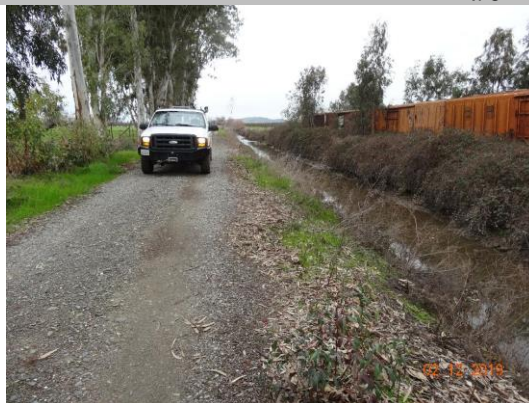
Photo 1 of 3 : UCIP\_SP\_2019\_53713\_79002.jpg

Overview of levee section (high ground) where pipe should cross.

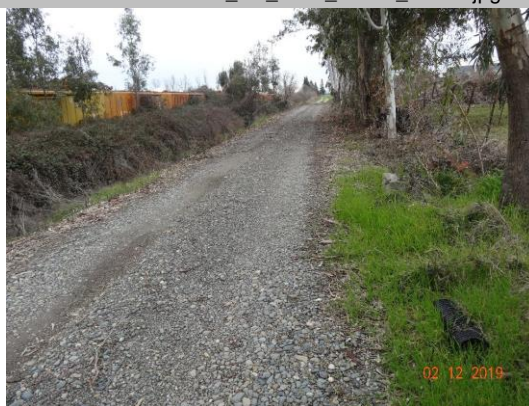
Photo 1 of 3 : UCIP\_SP\_2019\_53714\_79005.jpg

Overview of levee section (high ground) looking east towards crossings, 5- and 7-inch pipes.

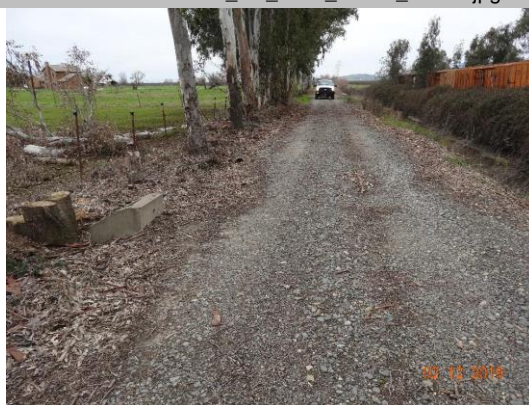
Photo 2 of 3 : UCIP\_SP\_2019\_53714\_79006.jpg

Overview of levee section (high ground) looking west, concrete box located on LS shoulder.

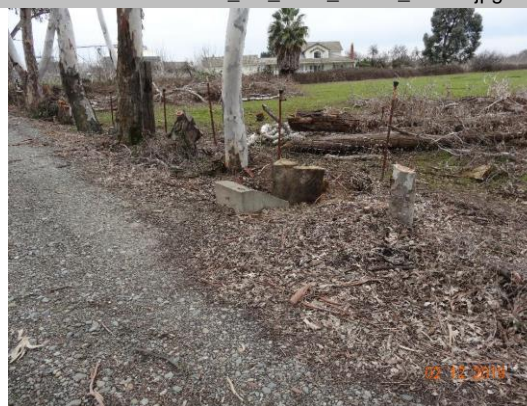
Photo 3 of 3 : UCIP\_SP\_2019\_53714\_79009.jpg

LS view: overview of LS.

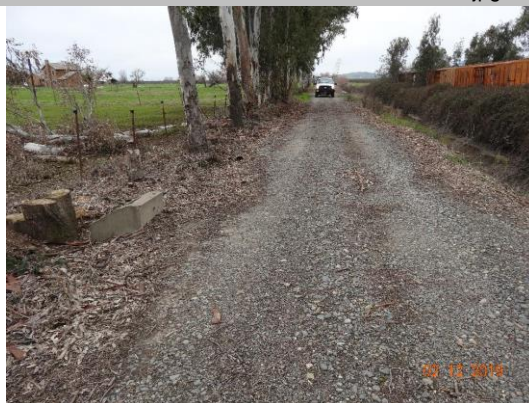
Photo 2 of 3 : UCIP\_SP\_2019\_53715\_79010.jpg

Overview of levee section (high ground) where pipe crosses, concrete headwall visible on LS shoulder.

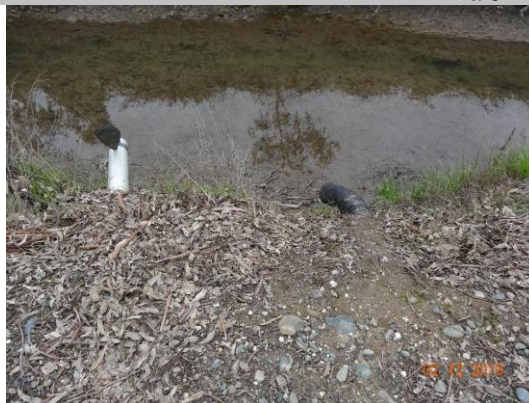
Photo 3 of 3 : UCIP\_SP\_2019\_53715\_79011.jpg

WS view: 5-inch steel and 7-inch HDPE pipes visible on WS.

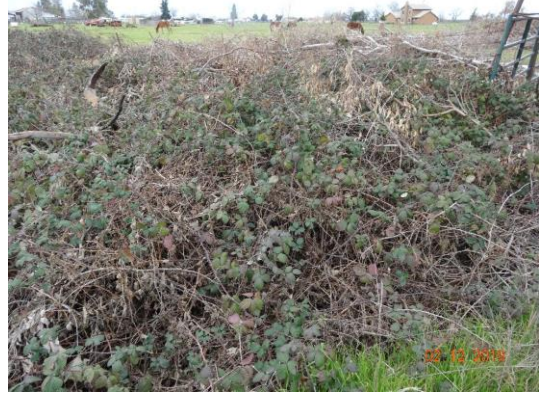
Photo 1 of 3 : UCIP\_SP\_2019\_53716\_79013.jpg

LS view: dense vegetation covers LS shoulder making it difficult to find pipe.

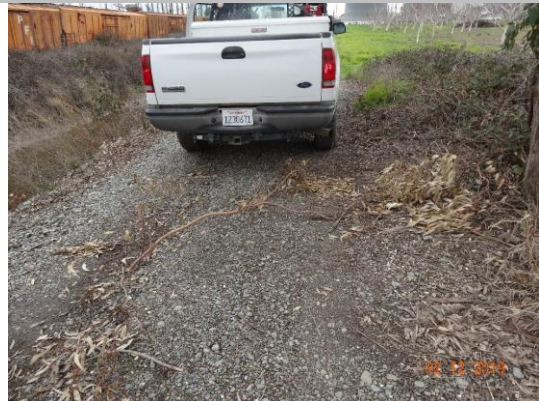
Photo 2 of 3 : UCIP\_SP\_2019\_53716\_79015.jpg

Overview of levee section (high ground) where pipe should cross.

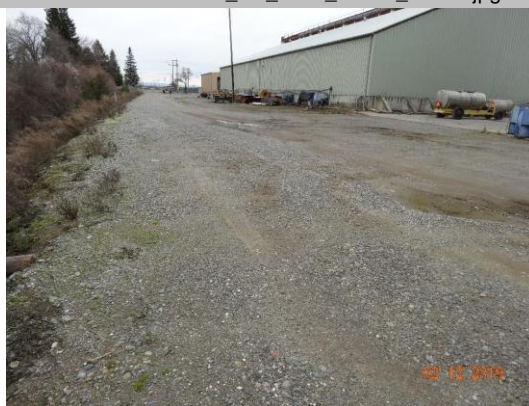
Photo 1 of 3 : UCIP\_SP\_2019\_53717\_79017.jpg

Overview of levee section (high ground) where pipe crosses.

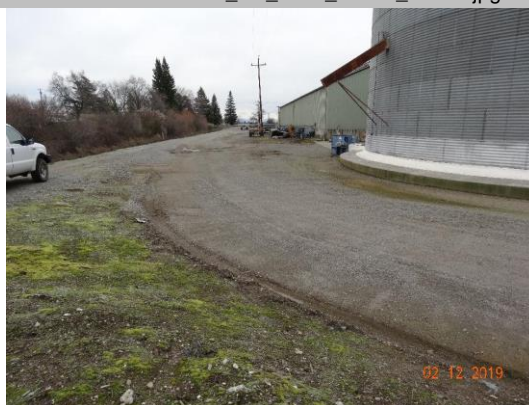
Photo 2 of 3 : UCIP\_SP\_2019\_53717\_79020.jpg

LS view: overview of LS with minor elevation change between LS ground and levee section (high ground).

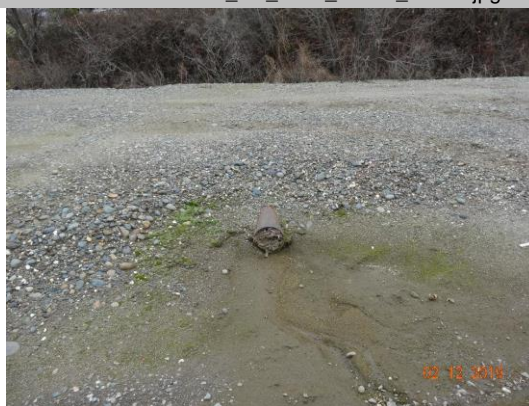
Photo 3 of 3 : UCIP\_SP\_2019\_53717\_79018.jpg

LS view: 6.5-inch steel pipe visible on the LS shoulder.

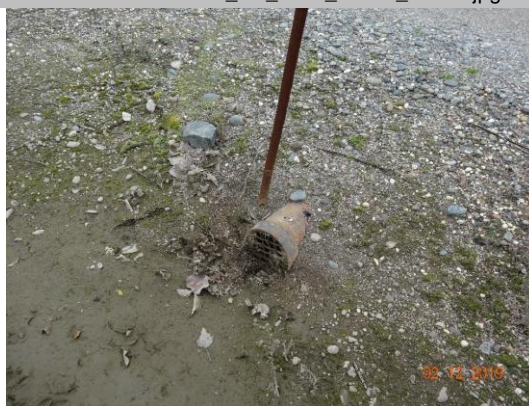
Photo 3 of 3 : UCIP\_SP\_2019\_53718\_79022.jpg

LS view: pipe inlet with screen to prevent pipe from clogging.

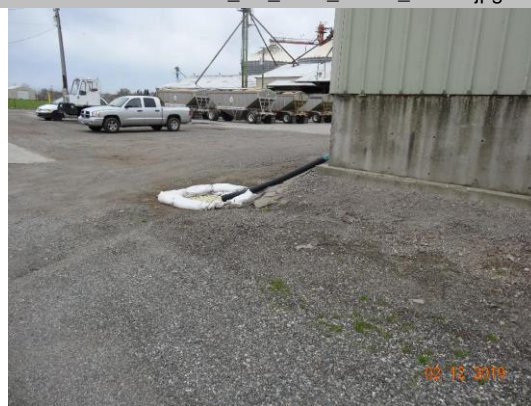
Photo 3 of 3 : UCIP\_SP\_2019\_53719\_79028.jpg

LS view: pipe inlet is about 250 feet south from levee near building corner.

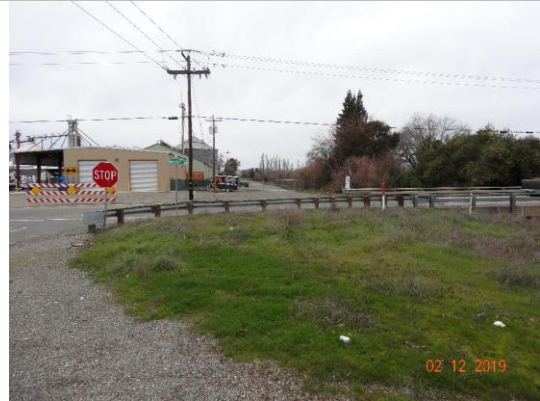
Photo 1 of 3 : UCIP\_SP\_2019\_53723\_79045.jpg

Overview of levee section (high ground) where com, gas, and drain line cross, photo taken looking east towards crossings.

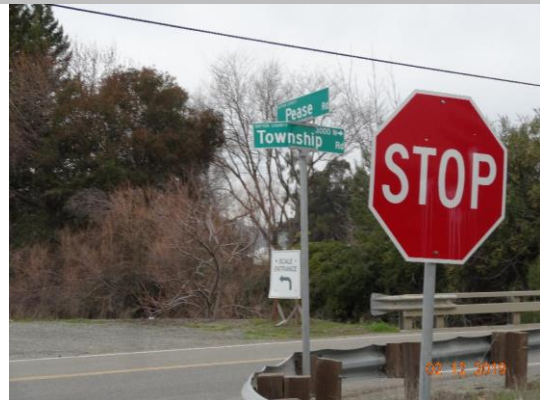
Photo 2 of 3 : UCIP\_SP\_2019\_53723\_79050.jpg

WS view: levee section at Pease Rd and Township Rd.

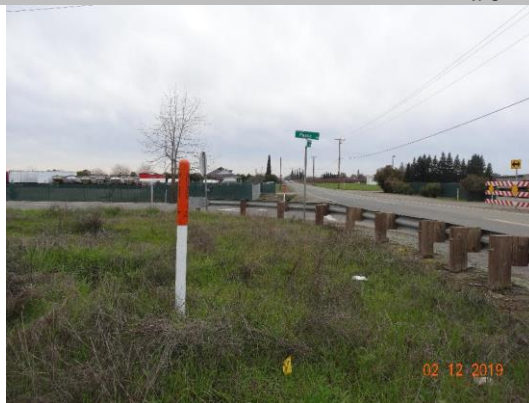
Photo 3 of 3 : UCIP\_SP\_2019\_53723\_79048.jpg

Comment Code						
Inspector Comment						
FS_ID:53723 DS_ID:20125 EP_NO: N/A Repair Type: Non-Urgent Crossing Status: Found UCIP Comments: 02/12/2019 (O. Magana - DWR UCIP)4/10/2017 Crossing appears to be in good condition. (DWR Sutter Yard-AFreitag)10/11/2016 Crossing appears to be in good condition.(DWR Sutter Yard - afreitag)4/19/2016 Crossing appears to be in good condition.5/12/2015 Crossing appears in good condition. No noticeable issues to report.11/17/2014 Same as last inspection.5/12/2014 Same as last inspection.11/4/2013 Same as last inspection.5/15/2013 Same as last inspection.10/16/2012 No permit identified for this crossing. FIELD_STRUCT_DESC: Steel fiber optics conduit of an unknown size through the levee, at an unknown depth. Crossing is located on the east side of Township Road bridge. Marker visible on east side of North Township Drive, south of interceptor. Owner is Pacific, and their contact number is 1-877-735-7366. No permit has been identified since crossing was field discovered in 2012. FS Date: 2/12/2019 2:59:00 PM

WS view: communication markers continue along the south portion of Township Road.

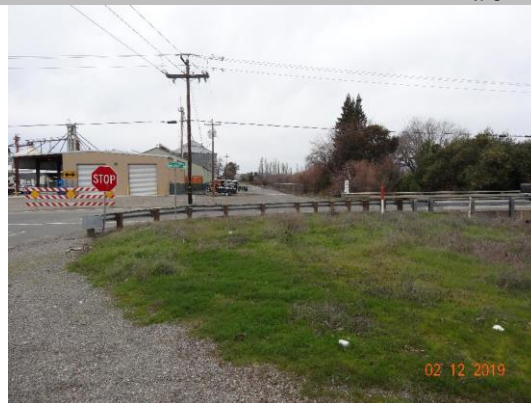
Photo 1 of 3 : UCIP\_SP\_2019\_53720\_79031.jpg

Comment Code						
Inspector Comment						
FS_ID:53720 DS_ID:20126 EP_NO: N/A Repair Type: Non-Urgent Crossing Status: Found UCIP Comments: 02/12/2019 (O. Magana - DWR UCIP)4/10/2017 Crossing appears to be in good condition. (DWR Sutter Yard-AFreitag)10/11/2016 Crossing appears to be in good condition.(DWR Sutter Yard - afreitag)4/19/2016 Crossing appears to be in good condition.5/12/2015 Crossing appears in good condition. No noticeable issues to report.11/17/2014 Same as last inspection.5/12/2014 Same as last inspection.11/4/2013 Same as last inspection.5/15/2013 Same as last inspection.10/16/2012 No permit identified for this crossing. FIELD_STRUCT_DESC: Steel gas line crossing of an unknown size through the levee, at an unknown depth. Sign visible on the landside (LS). No permit has been identified since crossing was field discovered in 2012. FS Date: 2/12/2019 2:59:00 PM

Overview of levee section at Township Road and Pease Road.

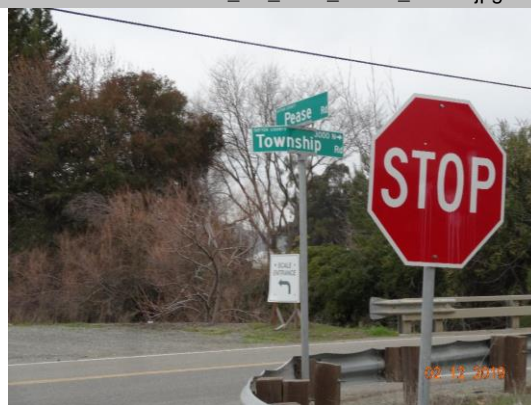
Photo 2 of 3 : UCIP\_SP\_2019\_53720\_79036.jpg

WS view: bridge crossing located on Pease Rd and Township Rd.

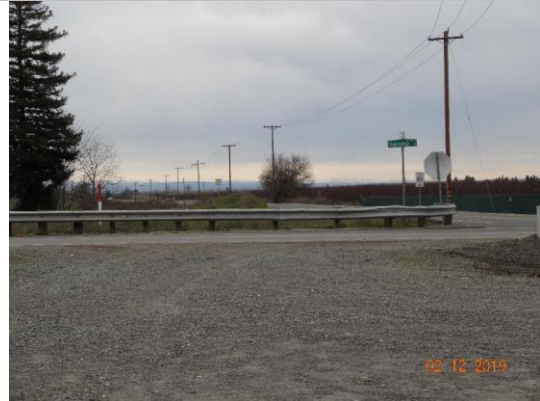
Photo 1 of 3 : UCIP\_SP\_2019\_53721\_79038.jpg

Comment Code					
Inspector Comment					
FS_ID:53721 DS_ID:20127 EP_NO: N/A Repair Type: Non-Urgent Crossing Status: Found UCIP Comments: 02/12/2019 (O. Magana - DWR UCIP)4/10/2017 Blackberries around the WS pipe outlet were aprayed and killed. Pipe appears to be in good condition. (DWR Sutter Yard-AFreitag)10/11/2016 WS flap gate is being overgrown by blackberries that could possibly hinder its operation. They should be sprayed and cleared back.(DWR Sutter Yard - afreitag)4/19/2016 Crossing appears to be in good condition.5/12/2015 Crossing appears in good condition. No noticeable issues to report.11/17/2014 Same as last inspection.5/12/2014 Same as last inspection.5/15/2013 Same as last inspection.11/4/2013 Same as last inspection.10/16/2012 No permit identified for this crossing. FIELD_STRUCT_DESC: 18-inch asphalt coated corrugated metal drainage pipe through the levee, 6 feet below the crown. Flap gate is located on the waterside (WS). Pipe is visible on the landside (LS) toe. No permit has been identified since crossing was field discovered in 2012. FS Date: 2/12/2019 3:00:00 PM

Overview of levee section (high ground), looking east towards multiple crossings.

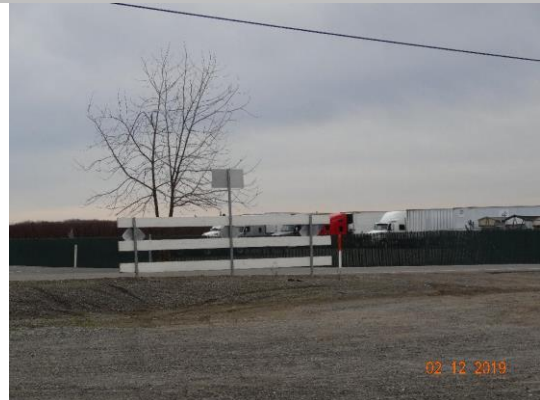
Photo 2 of 3 : UCIP\_SP\_2019\_53721\_79039.jpg

Overview of levee section (high ground), looking south towards multiple crossings.

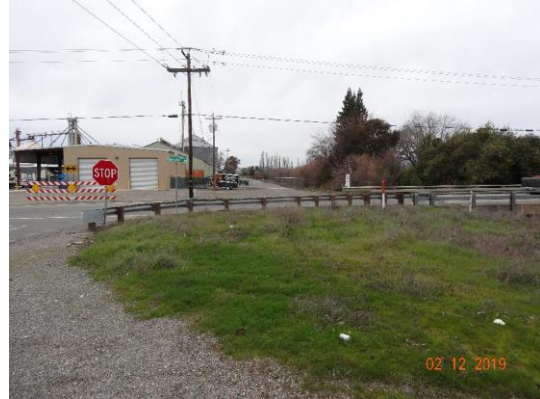
Photo 3 of 3 : UCIP\_SP\_2019\_53721\_79040.jpg

Comment Code						
Inspector Comment						
FS_ID:53721 DS_ID:20127 EP_NO: N/A Repair Type: Non-Urgent Crossing Status: Found UCIP Comments: 02/12/2019 (O. Magana - DWR UCIP)4/10/2017 Blackberries around the WS pipe outlet were aprayed and killed. Pipe appears to be in good condition. (DWR Sutter Yard-AFreitag)10/11/2016 WS flap gate is being overgrown by blackberries that could possibly hinder its operation. They should be sprayed and cleared back.(DWR Sutter Yard - afreitag)4/19/2016 Crossing appears to be in good condition.5/12/2015 Crossing appears in good condition. No noticeable issues to report.11/17/2014 Same as last inspection.5/12/2014 Same as last inspection.5/15/2013 Same as last inspection.11/4/2013 Same as last inspection.10/16/2012 No permit identified for this crossing. FIELD_STRUCT_DESC: 18-inch asphalt coated corrugated metal drainage pipe through the levee, 6 feet below the crown. Flap gate is located on the waterside (WS). Pipe is visible on the landside (LS) toe. No permit has been identified since crossing was field discovered in 2012. FS Date: 2/12/2019 3:00:00 PM

Overview of levee section (high ground), looking west towards com, gas, and drainage line.

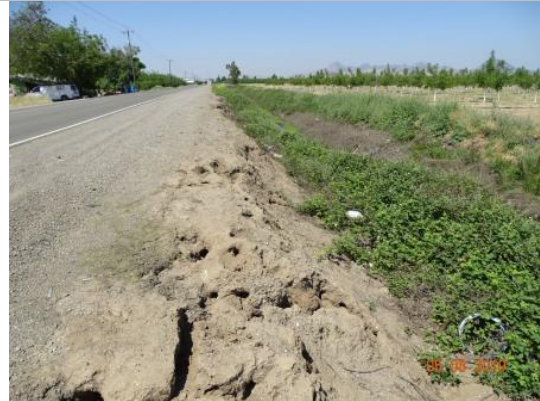
Photo 1 of 1 : SP\_2019\_ST0020\_214\_38\_20190510\_00087.jpg

LM Start	2.72	Rating **	U	Issue No.	38
LM End	2.72	Issue Type +	Ma	Location *	WS
Category	Earthen Levee			GPS Latitude/Longitude	
				Start	End
Item	Animal Control			39.170624 °	39.170624 °
				-121.675992 °	-121.675992 °
DWR ID	DWR_ST0020_02_s_2019_38				
Comment Code					
A3 : No rodents visible, but rodent burrows visible; need to backfill and compact or grout burrows.					
Inspector Comment					
Significant rodent activity is present. The surface runoff is further eroding the waterside shoulder/slope.

View of significant rodent activity on the waterside slope. Spring 2019.
